# **Now That's a Detour!**

## **Traffic Control Challenges on Large Construction Detours Affecting Multiple States**

**Richard C. Moeur, P.E.**  
Traffic Engineering Group  
Arizona Department of Transportation

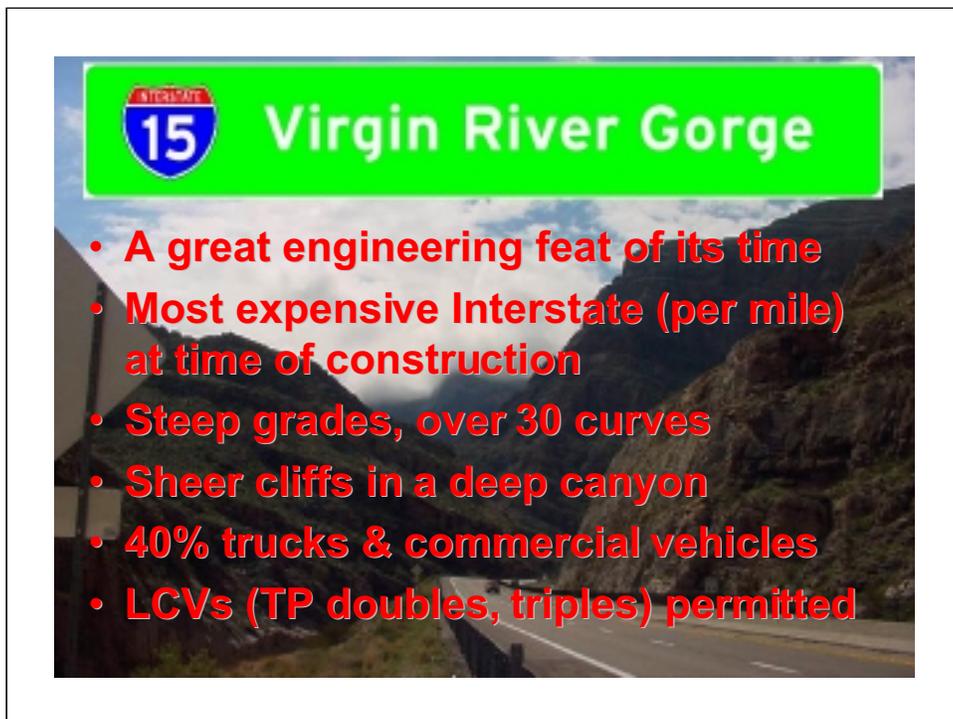
Interstate 15 travels for 29.4 miles in Arizona, connecting the cities of Mesquite, Nevada, and St. George, Utah. I-15 in Arizona generally runs parallel to the Virgin River, and for a few spectacular miles travels within the Virgin River Gorge.

I-15 through the Virgin River Gorge is an engineering *tour de force*, and is considered one of the great engineering feats of the mid-20th century. At the time of its construction in the early 1970s, this segment of highway was the most expensive single stretch of Interstate freeway on a per-mile basis in the entire United States. It travels through extremely challenging terrain, including steep grades and over 30 curves (some rather sharp) as it winds between sheer cliff faces. Over 40% of the traffic on this highway consists of trucks and other commercial vehicles - including the presence of “turnpike doubles” (a truck with two full size trailers ) and “triples” (trucks with three 28’ trailers).

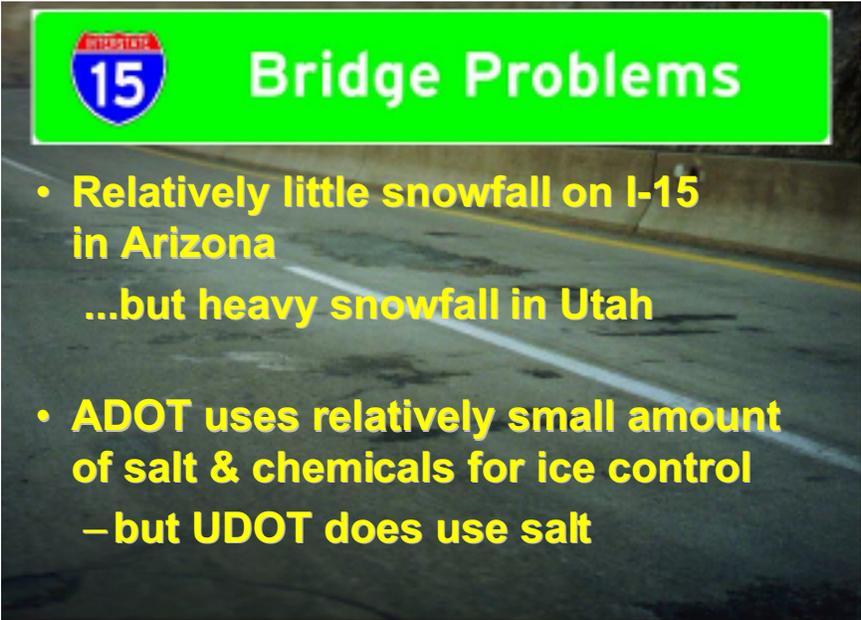
- **Northbound bridge decks suffered little damage over the years**
- **However, southbound bridge decks developed significant damage & potholes**

As the years passed, ADOT began noticing an interesting pattern in the decks of the bridges on I-15. While the northbound lanes of the bridges showed little damage, the bridge decks on the southbound lanes began to show a significant amount of damage and deck failure.

It seems that some of the salt used in Utah for deicing was being carried southward by traffic, and was being deposited on the southbound I-15 bridges in Arizona as snow melted and fell off the vehicles. This salt then began to attack the concrete and steel in the bridge deck, and combined with the occasional boulder plummeting from the cliffs above, created a number of bridge deck failures on I-15.

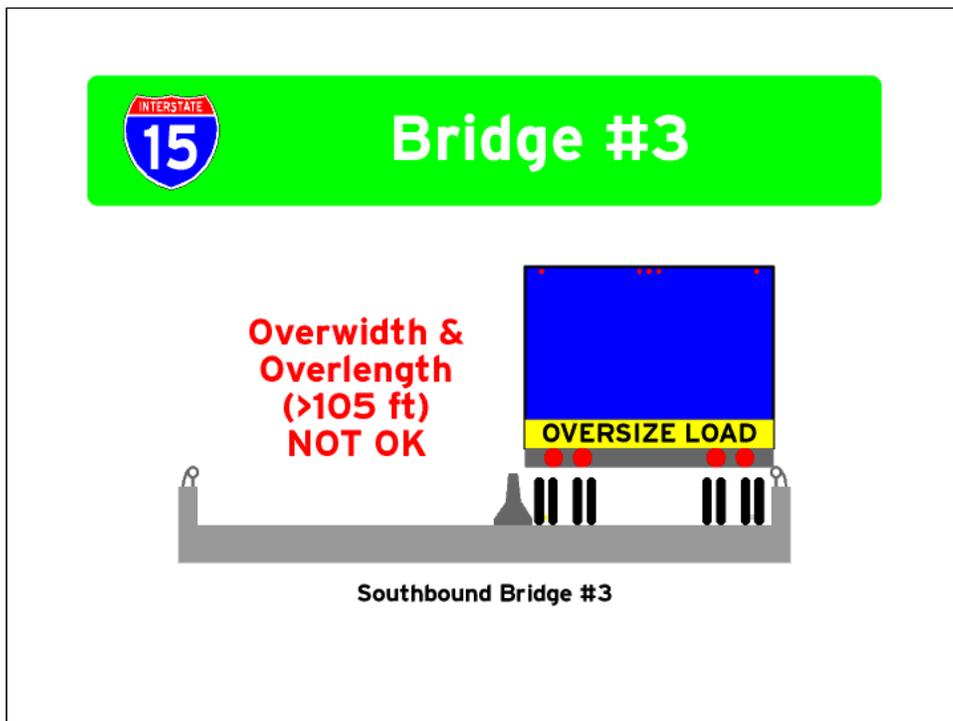
The southbound half of bridge 3 is only 30 ft wide - not much wider than two standard travel lanes. The single travel lane for southbound traffic was separated from the work zone by temporary concrete barrier. In order to accommodate the bridge reconstruction, the work zone needed to be at least 16 1/2 feet wide - leaving only 12 1/2 feet for southbound traffic between barrier faces. This, along with the curves, meant that standard-width trucks could squeeze through, but oversize or overlength loads would just not fit.

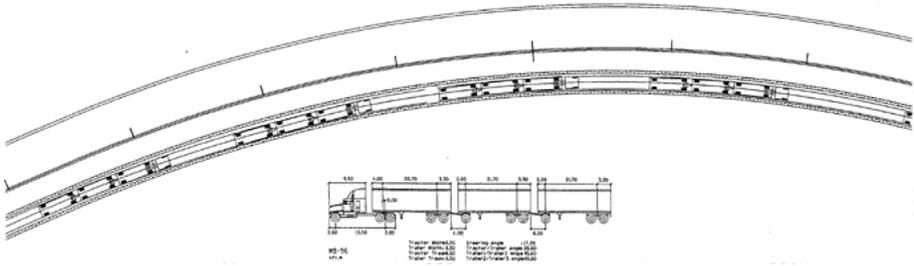
**Sample Turning Template Run - Triple Trailer Combination**

Here is an example of one of the tuning template analyses for bridge 3 - this one involving a triple trailer truck combination. Note how the swept width does get close to the barriers, but does not quite make contact.

- **Turning template and off-tracking analysis performed**
  - All standard STAA combinations OK
  - Rocky Mountain & Turnpike Doubles OK
  - Triple Trailers OK
    - ...but might leave a little rubber here & there
  - **Overwidth/Overlength (>105') NOT OK**

Due to the narrow lane widths, the curvilinear alignments, and the numerous heavy trucks and LCVs, there were concerns as to whether large vehicles could negotiate the work zone. Parsons Brinckerhoff, ADOT's traffic design consultant on this project, performed a analysis using computerized turning templates to see if larger vehicles would be able to navigate the lane restrictions on bridge 3. The analysis indicated that all standard width WB-series trucks would be able to fit (although the swept width on the triple trucks did get rather close to the barriers). However, this analysis also verified that it would be difficult or impossible for trucks wider than 10 feet or trucks longer than 105 feet to make it through the work zone.

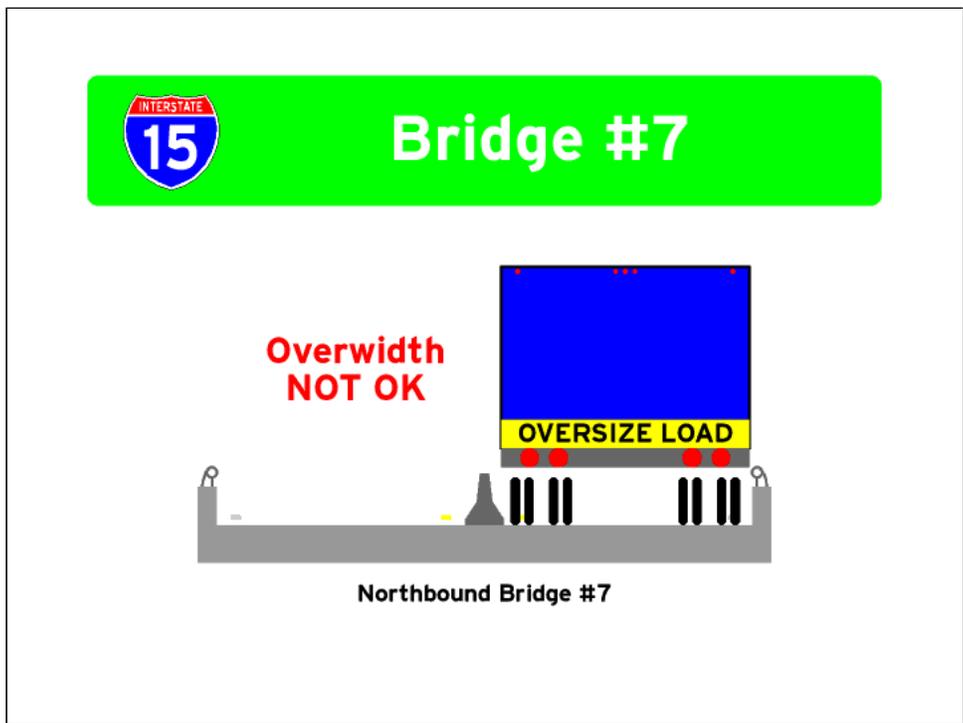
However, the northbound bridge is only 28 feet wide, which meant that, after the barrier was placed, there was only 13 feet of clear width for both northbound and southbound traffic. While this would accommodate standard-width trucks, it would be difficult or impossible for overwidth vehicles to traverse this closure.

The traffic control concept for bridge number 7 was similar to that for bridge 3, but fortunately at this location there was an opportunity to remove the median barrier on each end and carry the southbound traffic on the northbound bridge. Median crossovers using a 45 MPH design speed were constructed on each side, and a two-way two-lane detour operation, with each direction separated by temporary concrete barrier, was set up on the existing northbound bridge.

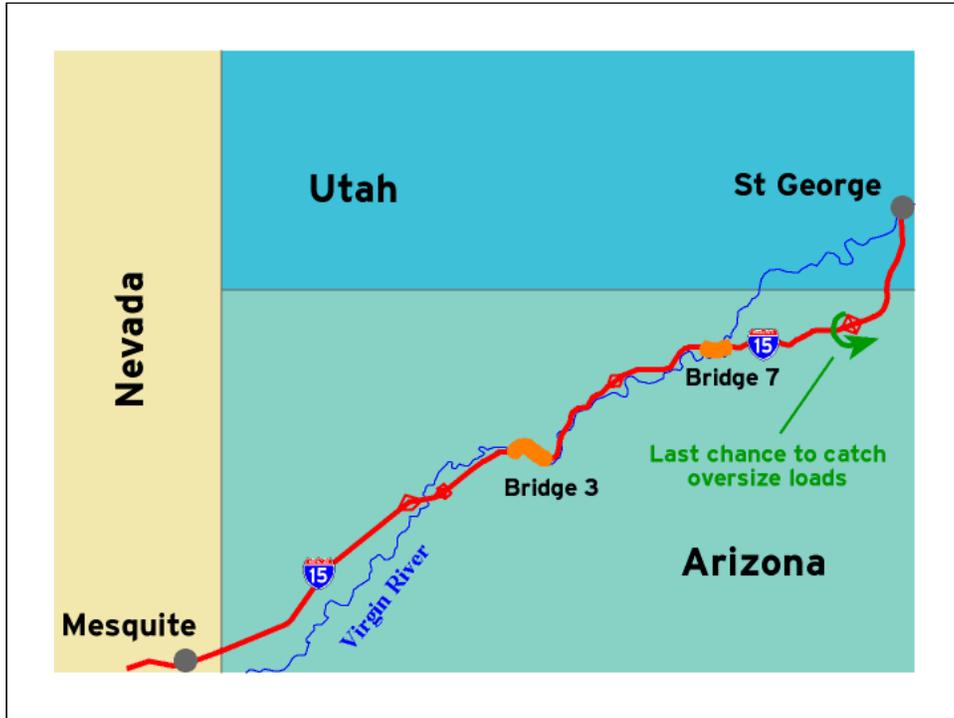
This brake check area was set up at the first interchange in Arizona, at the Black Rock Road traffic interchange.

Another innovative traffic control measure used on this project was the use of a mandatory brake check area for all large trucks traveling southbound on I-15 through the project. As they approached the location, regulatory signs directed trucks and other large vehicles into the right lane, and then directed them to exit at a minor interchange where the brake check area was set up. This brake check helped to ensure that commercial vehicles descending southbound through the I-15 work had cool and fully functioning brakes and other safety equipment.

This was manned on a 24 hour basis by staff from Arizona DPS and ADOT’s Motor Vehicle Division. These staffers worked with the truckers to advise them of the construction and restrictions in the area. Also, this brake check area provided a “last chance” for oversize and overlength loads (which somehow might have missed all the numerous signs leading up to the work area) to turn around and detour around the work site.

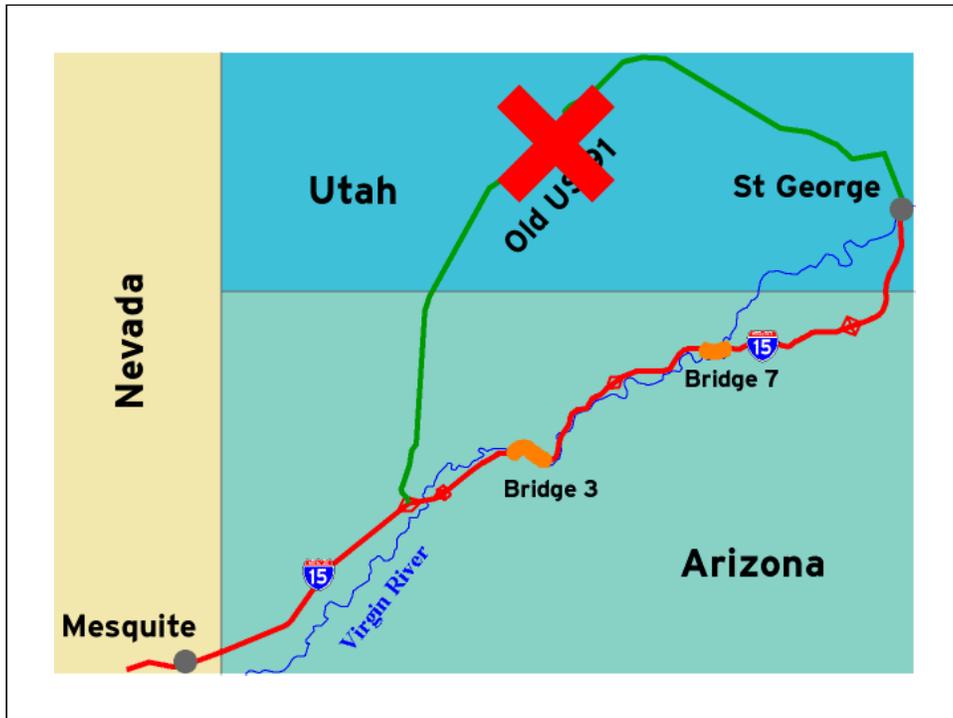
The first oversized load detour option that was investigated was the simplest - using the highway (Old US 91) that originally served this area prior to the construction of I-15. While this road is quite suitable for most of its length, the growth of the residential areas in southwestern Utah surrounding St. George and Santa Clara has drastically changed the character of these highways. What once was a rural two lane US highway now serves as a two lane residential street - and in these areas, it is no longer appropriate or feasible to route oversized loads down these streets, and this detour option was withdrawn from consideration.

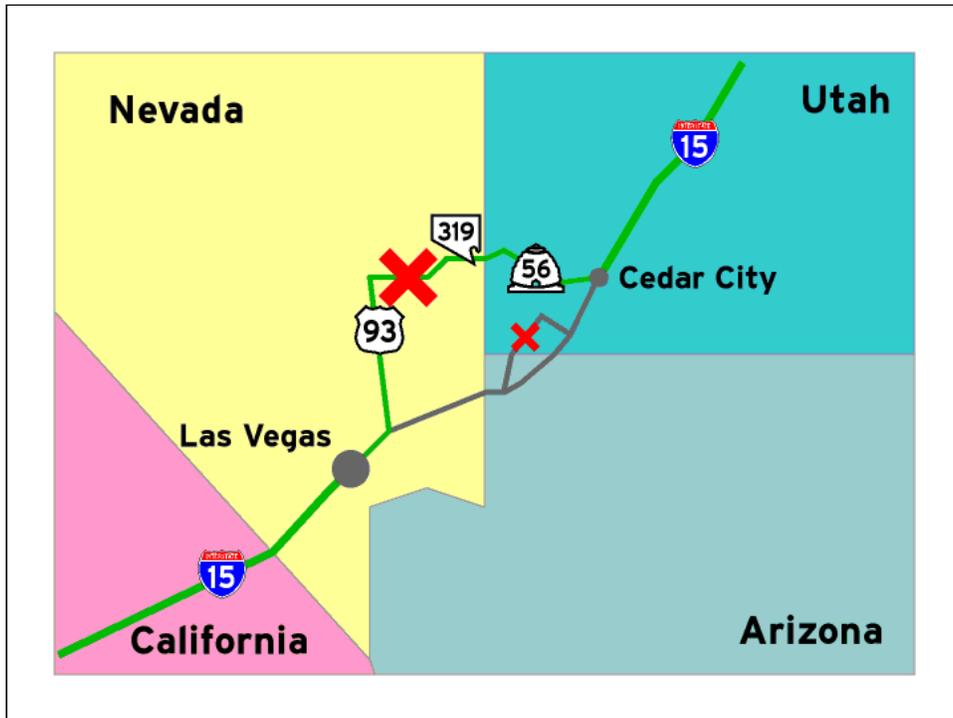
The next detour option that was evaluated looked at the use of US highway 93, Nevada state route 319, and Utah state route 56 to bypass the work zone. A field investigation by ADOT and other project staff confirmed the route's suitability for oversize loads. ADOT staff then visited the UDOT district office in Cedar City, and UDOT staff indicated their willingness to support this detour option.

ADOT project staff then presented this option to the Nevada DOT District 1 office in Las Vegas, and received the unhappy news that NDOT had scheduled a 45-mile long paving project along US 93 at the very same time as the work in Arizona - and neither project could be rescheduled. NDOT and ADOT agreed that the construction activities would make this route unsuitable for an I-15 oversize load detour at that time, and so this option was abandoned.

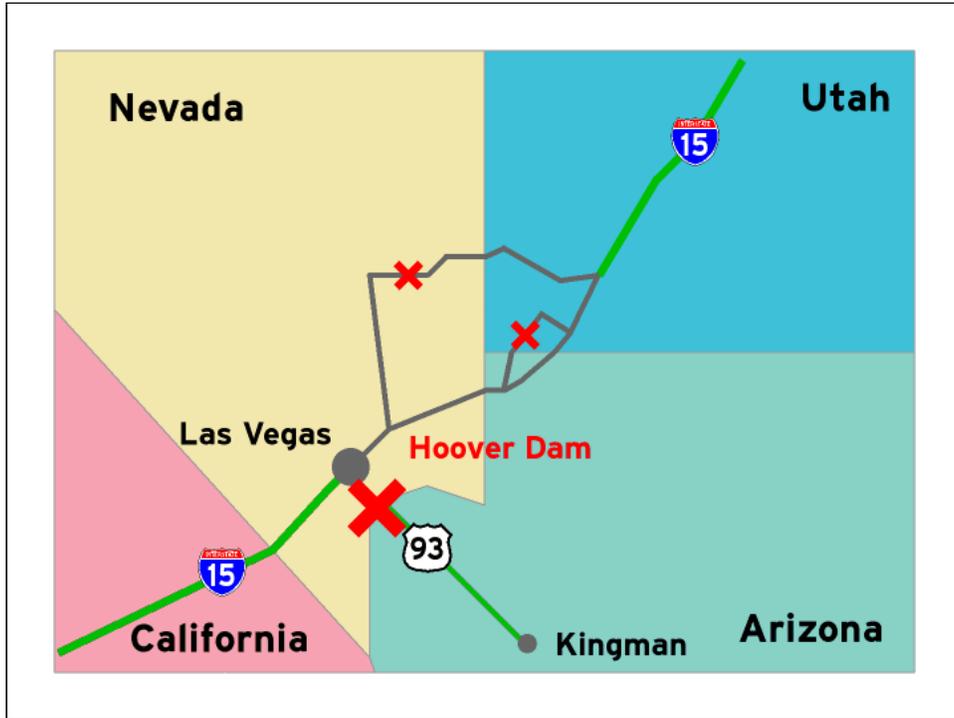
Another roadway option that exists in this area is US 93 south, which connects Las Vegas with Kingman, Arizona on I-40. However, this segment of US 93 is prohibited to all oversize loads due to the fact that US 93 travels over Hoover Dam - a narrow, winding trip that is difficult enough for legal-limit loads. So, until such time as a new bridge US 93 is constructed to provide a better route over the Colorado River in this area, this roadway cannot be used for oversize loads under any circumstances.

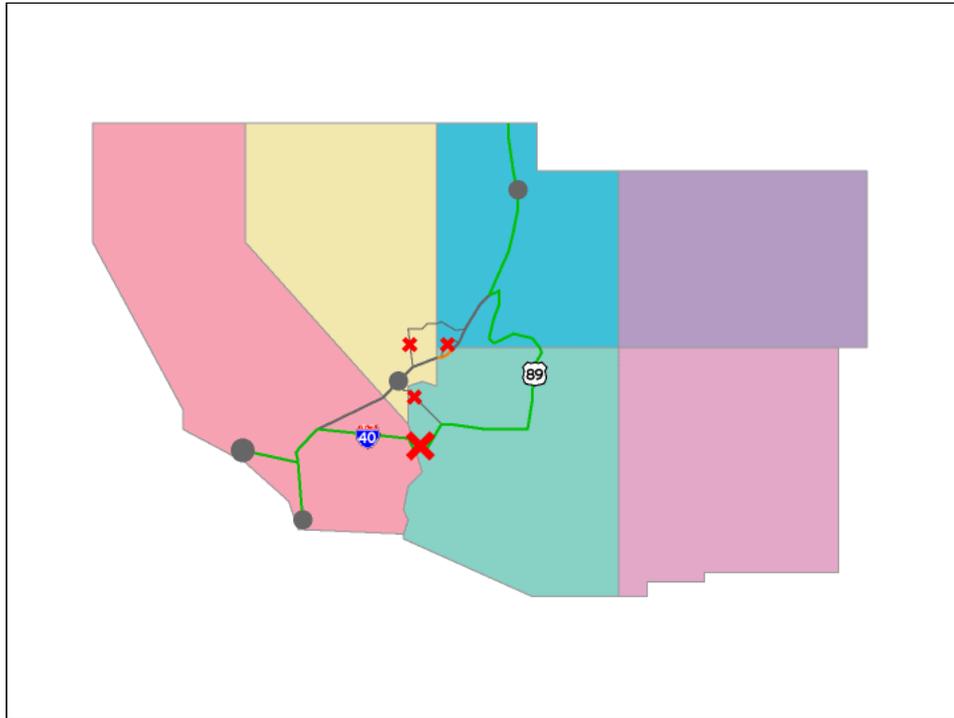
One detour option that immediately presented itself was to use I-40 and US 89 as a detour option, carrying oversized loads around the work area, diverging from I-15 at Barstow, California, traveling over to Flagstaff, Arizona, and then traveling up on US 89, rejoining I-15 and I-70 in central Utah.

In order to gain approval for this detour plan, ADOT staff paid a visit to their colleagues at the Caltrans District 8 office in San Bernardino, California. However, at this meeting, Caltrans advised the ADOT project staff of the unfortunate fact that many of the bridges and culverts along I-40 in California would be undergoing renovation and seismic retrofitting for the time period before, during, and after the Arizona I-15 project. So, this detour, which initially looked so promising, was no longer an option.

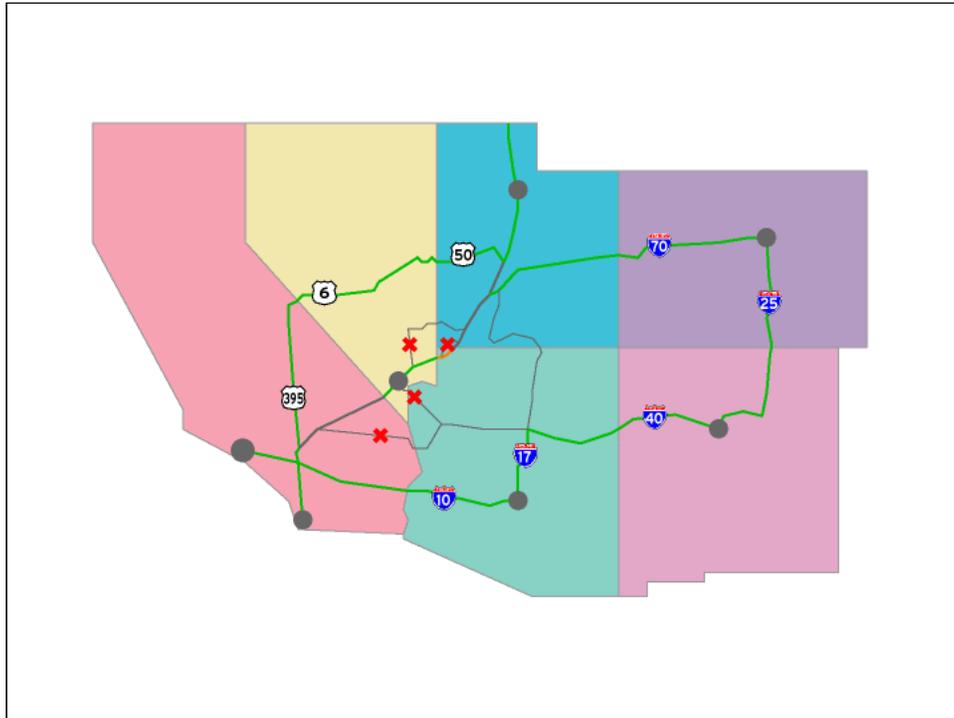
Now the project team was forced to look at some exceptionally long detours to accommodate oversized load travel. For example, traffic from southern California heading for central Utah and points north (or vice versa) could use a routing of US 395, US 6, and US 50. Or, a vehicle could use I-10, I-17, and US 89 to travel between central Utah and southern California. Loads traveling regionally or traveling across the country could be best served by a routing along I-10, I-17, I-40, and I-25 to Albuquerque, Denver, and points east and north.

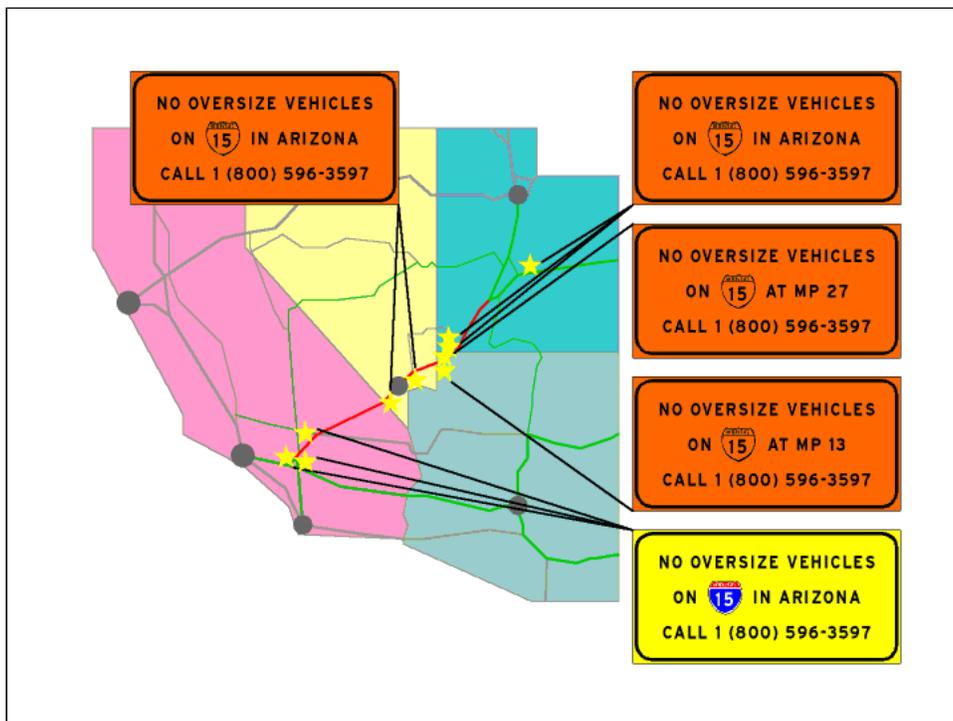
The signs shown were placed along I-15 and other major highways in four states. These signs measured 16 ft tall by 8 ft high, and used 10 in legend. Signs were placed in Utah on I-70 westbound, on I-15 southbound near Cedar City, and I-15 southbound prior to St. George. Signs were placed in Nevada on I-15 northbound north of the California border, and on I-15 northbound prior to the US 93 north junction. Signs were placed in California on I-15 and I-215 northbound just north of San Bernardino, and on California state route 58 eastbound near Barstow. Signs were also placed in Arizona on I-15 northbound just east of the Nevada border, and on I-15 southbound just south of the Utah border.

In order to accommodate all four states' work zone signing standards and guidelines, the signs were made of flat sheet plywood and placed on drilled wood posts, which combined strength while also providing adequate breakaway capability if struck by an errant vehicle.

Although it was the designer's intent to have the Interstate shields in color on all the signs, the contractor's sign manufacturer made the orange signs with black shields because, according to them, the project plans did not explicitly state that the signs were to be in color.

Note that the signs placed in California were yellow, instead of the more typical orange used for temporary signs. Caltrans felt that yellow warning signs were more appropriate for this application. Also, Caltrans clearly specified to the contractor to use colored Interstate shields.
